Stacked Plywood Strips Transom Repair

This repair is time consuming, as is the drying time for both the wet wood and the chemicals. This job took me 180 hours over a 4-month period. This included the removal and reinstallation of the interior in the rear and a thorough cleaning of the entire boat once the repair was completed. The boat is a 1977 19' SeaRay SRV197.

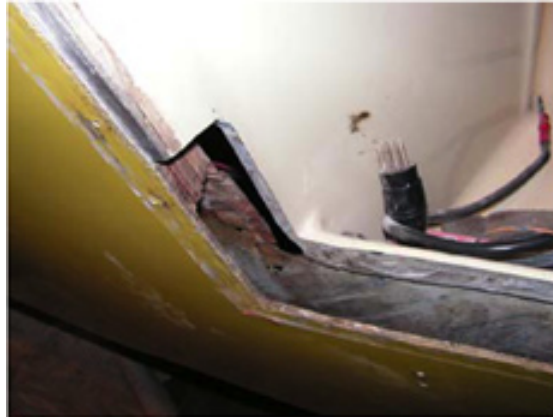
I began by cutting the transom top and part of sides to provide access to the wet and rotted wood.

Other side was cut similarly

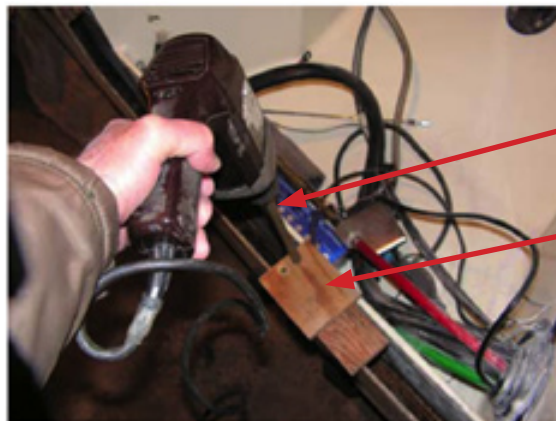
I dug out most of the rotted wood with a hook shaped tool and a 1¼ inch spade bit on a long extension. I also used a 1½ inch spade bit with a jig to limit the depth of the drilling and to produce a flat and square bottom of the dugout area. This was done to provide a level starting point for the first layer of the plywood strips.

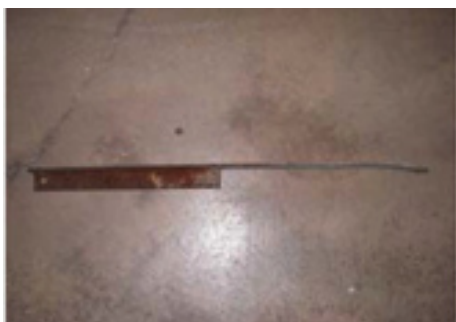
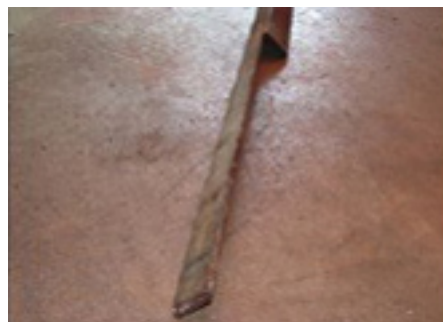
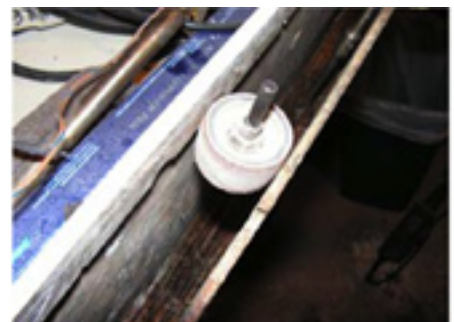
I squared the dugout sides using a home made 'chisel' made by cutting off part of one side of a piece of 2 inch X 2 inch angle iron. I sharpened the end of the blade portion by grinding to make a cutting edge. It was about 3 feet long and I was able to use it without a hammer. That made it easy. I bent the end of the chisel slightly near the tip so I could use it along with a 1½ inch drum sander to clean the wood from the fiberglass sides of the dugout area. This worked very well.
