Stacked Plywood Strips Transom Repair

This repair is time consuming, as is the drying time for both the wet wood and the chemicals. This job took me 180 hours over a 4-month period. This included the removal and reinstallation of the interior in the rear and a thorough cleaning of the entire boat once the repair was completed. The boat is a 1977 19' SeaRay SRV197.

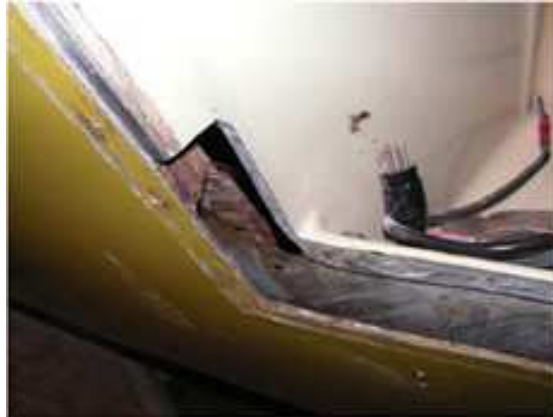
I began by cutting the transom top and part of sides to provide access to the wet and rotted wood.

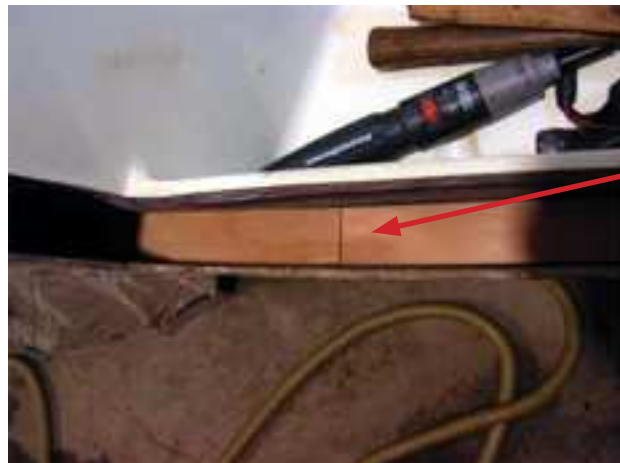
Staggered wood strip joint

I used fir marine plywood for maximum strength. I cut the plywood into 1½ inch wide strips so they would just fit in the transom opening width. I then cut them to match the contour and length of the traced shape. I made the longer strips in two pieces to allow them to be installed. I staggered the joints of the strips so that they all were near the sides of the transom opening and not in the middle where most of the bending load is. I inserted a nylon strap loop into the opening before fitting the wood strips to make it easy to remove them. It is not necessary to be totally accurate cutting the end contour of the strips, but the length is critical for maximum strength. I left as little a gap between the ends plywood strips as possible.

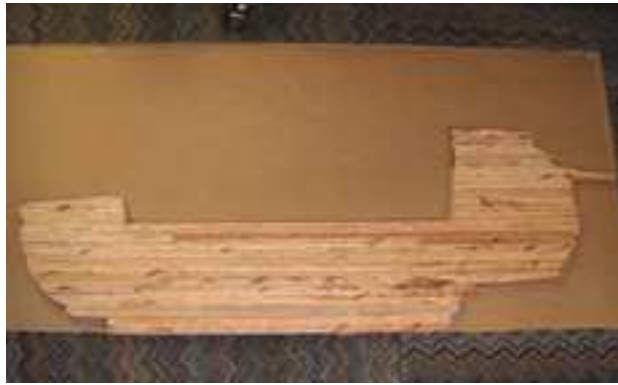
All wood strips cut

I removed the strips one layer at a time by pulling on the nylon strap. As I remove them, I marked each strip with information that would allow me to replace them in the right order. A pencil is suggested for marking the wood as it will not run or disappear when the CPES is applied.

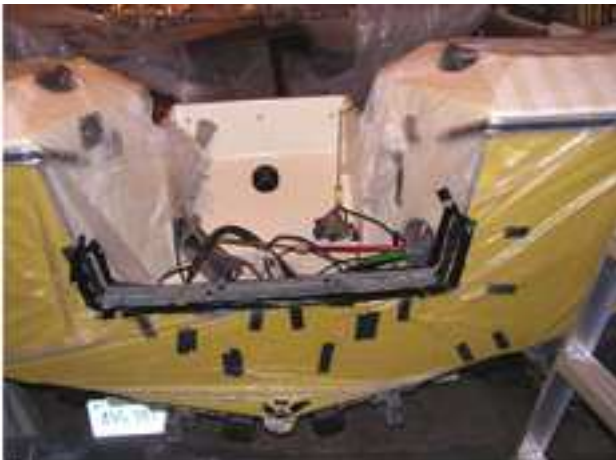
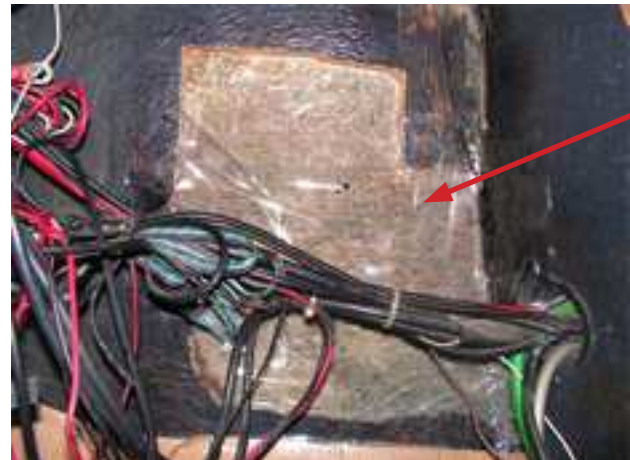
Inside break-through area

I carefully covered all small holes and bolt holes on the outside of the transom with electricians tape to contain the CPES and the L&L epoxy. I made sure the tape was not concave into the holes, to prevent the opening from being concave once the L&L set. I also used some strong clear packaging tape on larger areas on the inside of the transom where the fiberglass broke through when removing the rotted wood. The tape was used to contain the CPES and L&L. Both tapes worked very well.

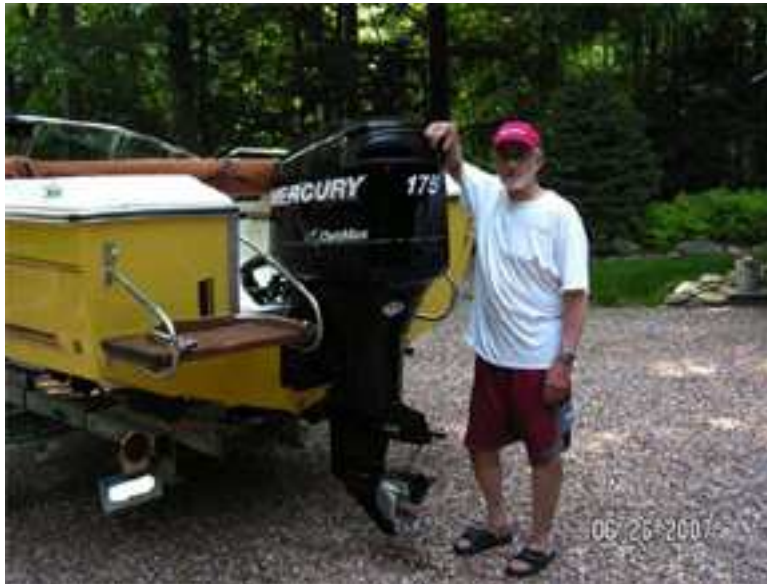
New outboard installed

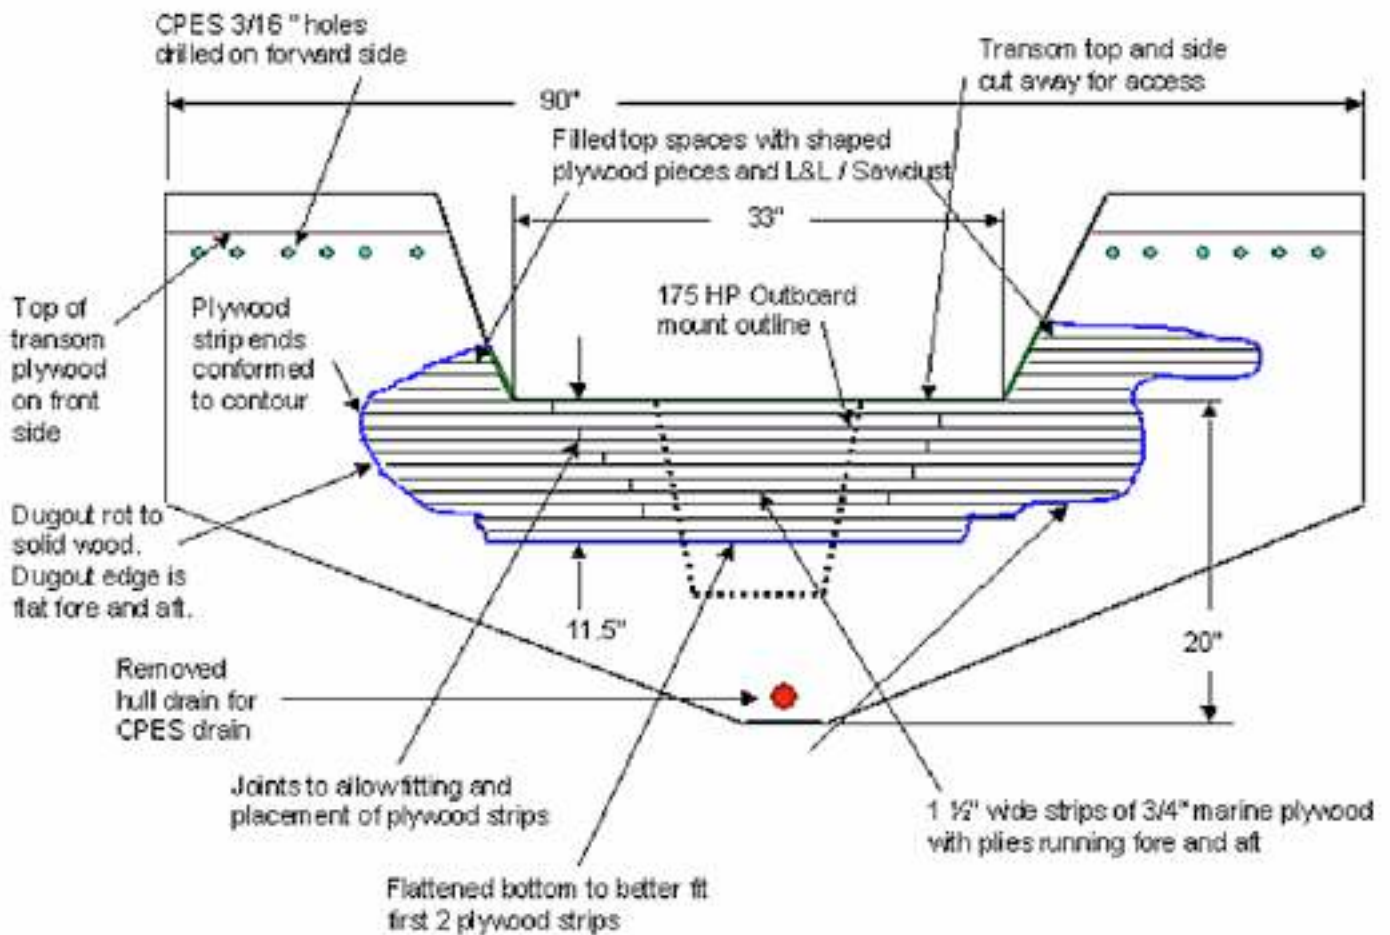
Transom Repair Drawing

As an engineer, I consider this stacked plywood strips method of transom repair structurally stronger than the other methods I reviewed. The ratio of plywood to epoxy is better than other methods. This makes it a stronger structure. The fore and aft orientation of the plywood layers is similar to a laminated main supporting floor beam in a house only oriented horizontally in the direction of the transom loads. This transom repair has proven to be very strong and very stiff with the 71-pound heavier motor. The transom is good for another 30 years.
