Stacked Plywood Strips Transom Repair

This repair is time consuming, as is the drying time for both the wet wood and the chemicals. This job took me 180 hours over a 4-month period. This included the removal and reinstallation of the interior in the rear and a thorough cleaning of the entire boat once the repair was completed. The boat is a 1977 19' SeaRay SRV197.

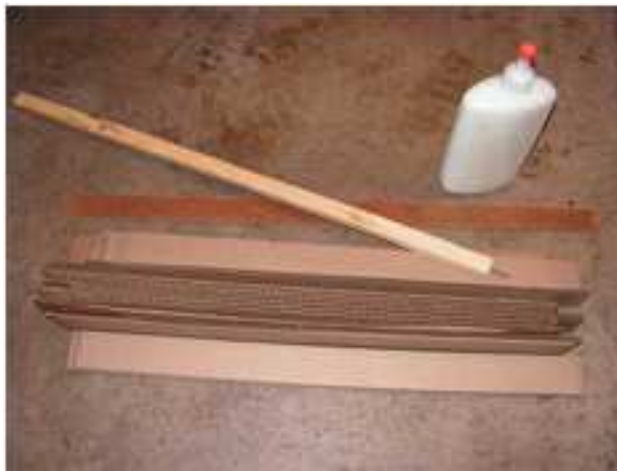
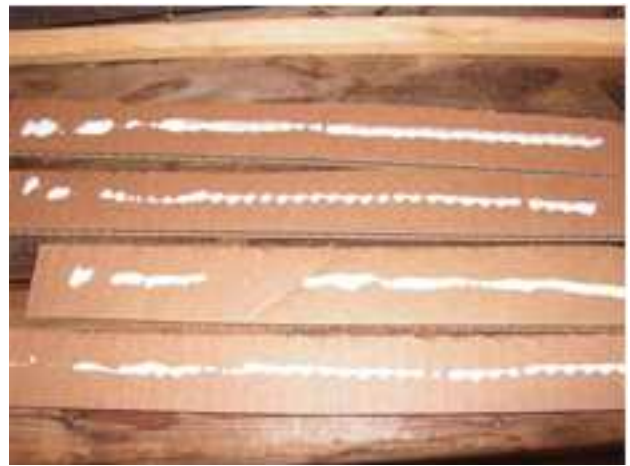
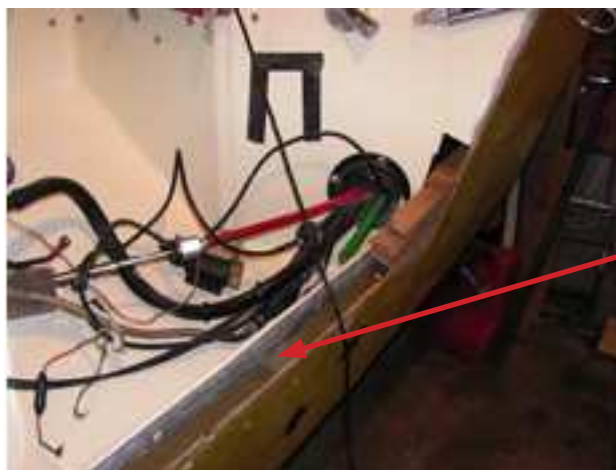
Left and right halves temporarily tied together with a screw for reassembly once removed.

I duplicated the contour of the dugout area using many strips of cardboard laid flat and glued together along the center of each strip. The strips were cut about $\frac{1}{2}$ inch narrower than the transom opening to make them easier to install and remove. I used a small piece of wood about 18 inches long with a sharpened nail in the end to "stab" the cardboard strips to slide them in the glue to ensure they reached the sides. The two halves (left and right) needed to be tied together in place so that they could be reassembled at the same width once removed. This was done to provide an accurate template of the shape of the dugout area. I used four overlapping longer strips of Masonite in place of cardboard strips placing two near the bottom and two at top to tie the two halves together. It worked, but I would use strips of $\frac{1}{4}$ inch thick plywood the next time for more stiffness. I put a screw through the two pieces of overlapped Masonite at the bottom and top to keep the right distance apart for reassembling once removed. Once the two halves were removed, I assembled them with the screws and then traced the pattern for cutting the wood strips.

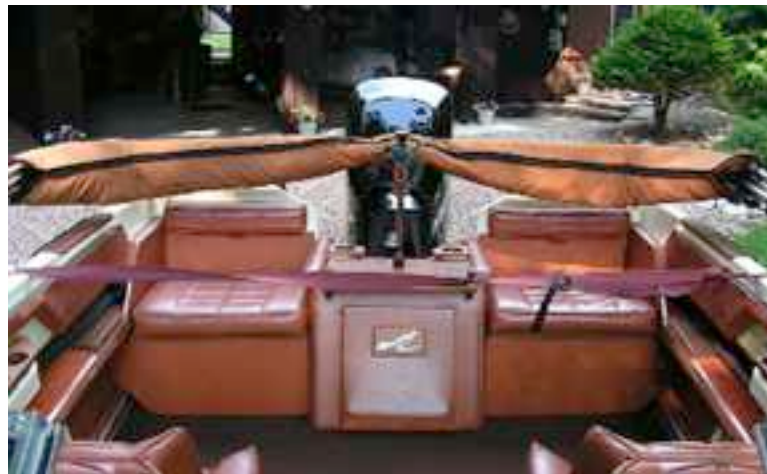
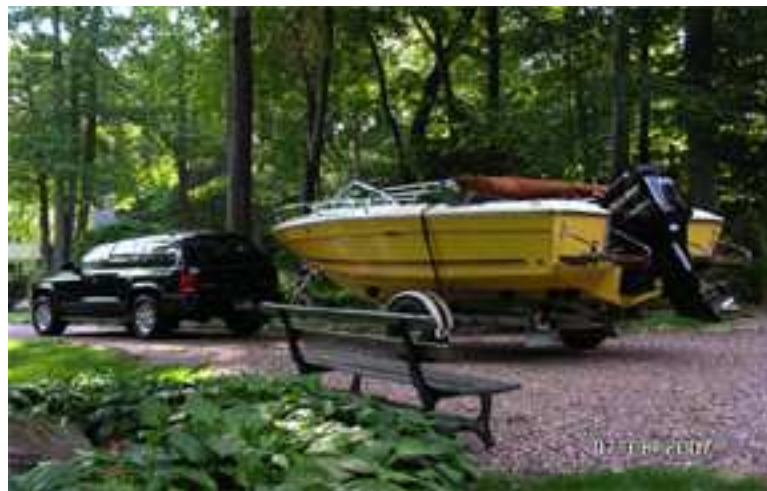
Well worth the wait

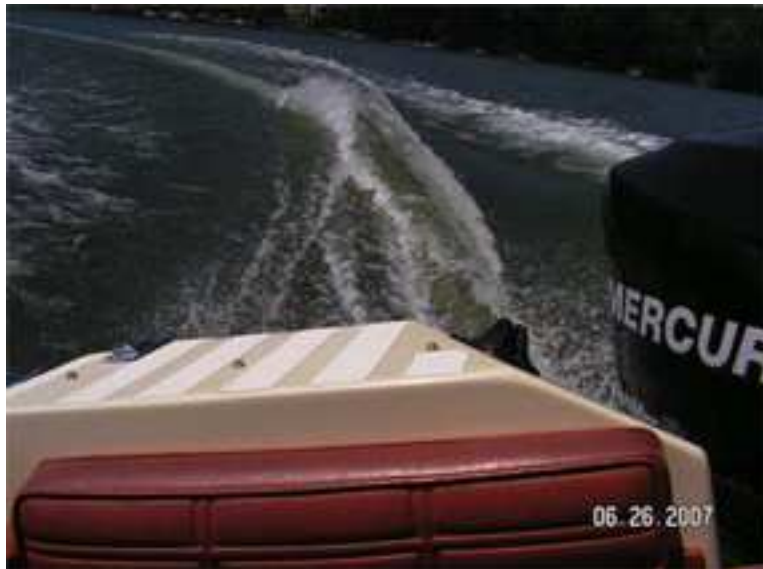
Transom Repair Drawing

As an engineer, I consider this stacked plywood strips method of transom repair structurally stronger than the other methods I reviewed. The ratio of plywood to epoxy is better than other methods. This makes it a stronger structure. The fore and aft orientation of the plywood layers is similar to a laminated main supporting floor beam in a house only oriented horizontally in the direction of the transom loads. This transom repair has proven to be very strong and very stiff with the 71-pound heavier motor. The transom is good for another 30 years.
